Manhole Inspection Summary

Manhole # S21CC1062MH

Record Plat: **21CC1** Node: **062** Status: **New Manhole (Not in GIS)** Insp Date: **3/20/07 12:00 AM**

Location Address: **1700 CLIPPER PARK RD**

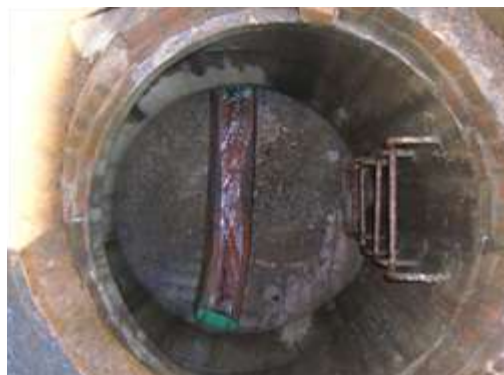
Top View

Evidence of surcharge - Bench debris.

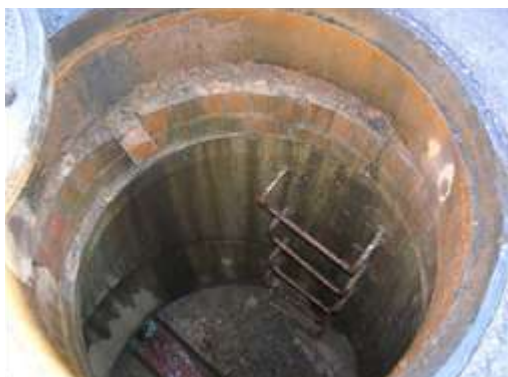
Defect

Frame leaks. Frame offset. Adjustment deterioration, loose brick and infiltration. Barrel infiltration.

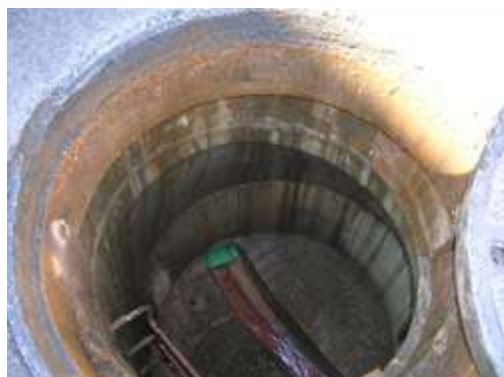
Defect

Frame leaks. Frame offset. Adjustment deterioration, loose brick and infiltration - other side.

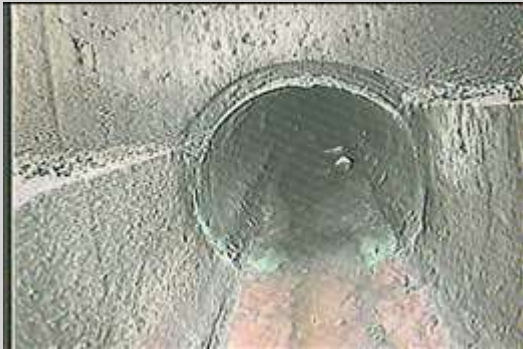
8 in. Circular Gravity Sewer Pipe Out @ 12 O'Clock

Infiltration: **Evidence** Pipe Seal Cond: **Unknown**

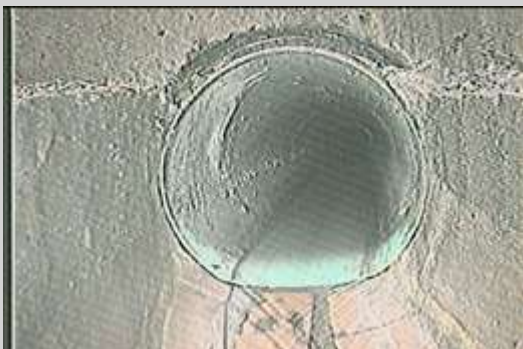
8 in. Circular Gravity Sewer Pipe In @ 7 O'Clock

Infiltration: **Evidence** Pipe Seal Cond: **Unknown**
